SITE VISIT REPORT SHEET REF NO.: 12

Construction Element: Concrete Roof

**Visual Inspection of Paralon warm roof installation;
ROOF 1A-1B**

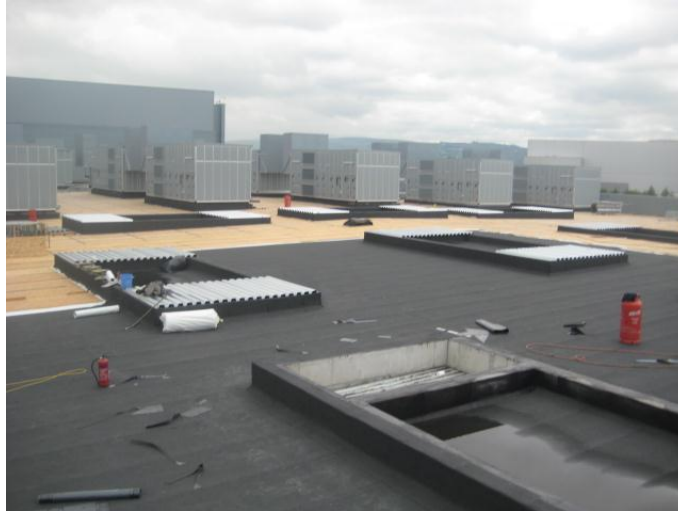
The Paralon warm roof installation is completed to the main roof field area and upstands up to and including fleece and timber protection with fixed metal strap on joints.

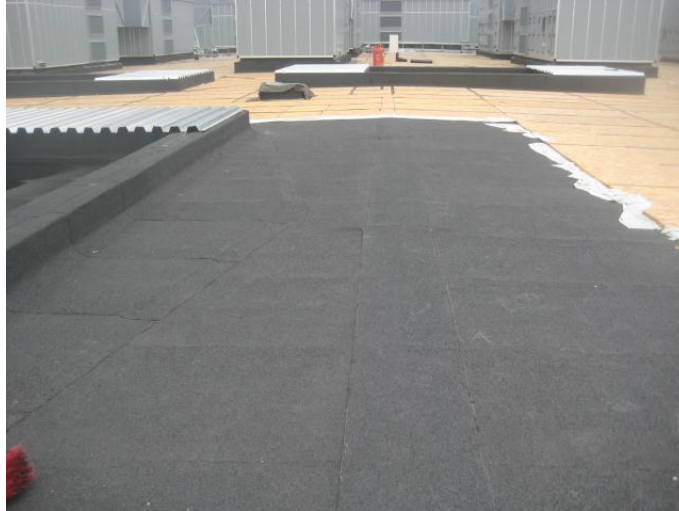
ROOF 4A-4B

The Paralon warm roof installation is completed to the main roof field area and upstands up to and including fleece and timber protection with fixed metal strap on joints.

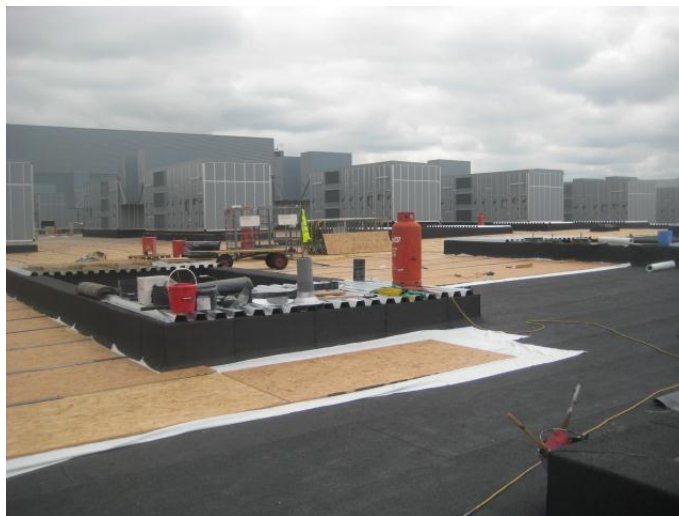
ROOF 5A-5B

The Paralon warm roof installation is completed to the main roof field area and upstands up to and including fleece and timber protection with fixed metal strap on joints.

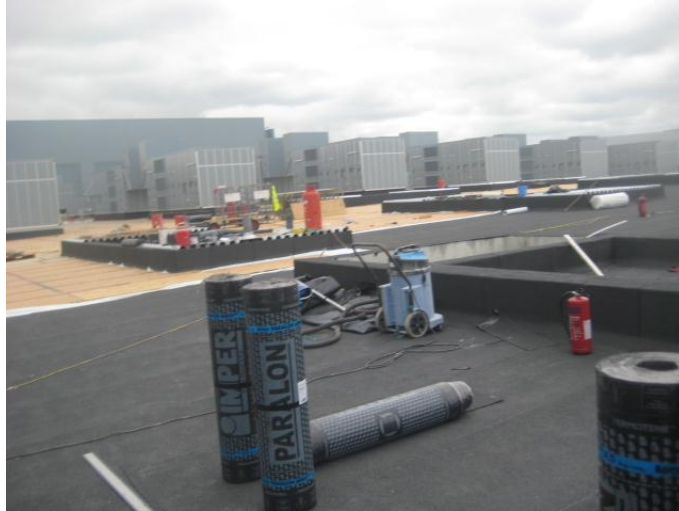
ROOF 6A-6B

The Paralon warm roof installation is completed to the main roof field area up to and including the Paralon Ard granular faced capsheet, the upstand waterproofing is completed up to and including 3mm base sheet.

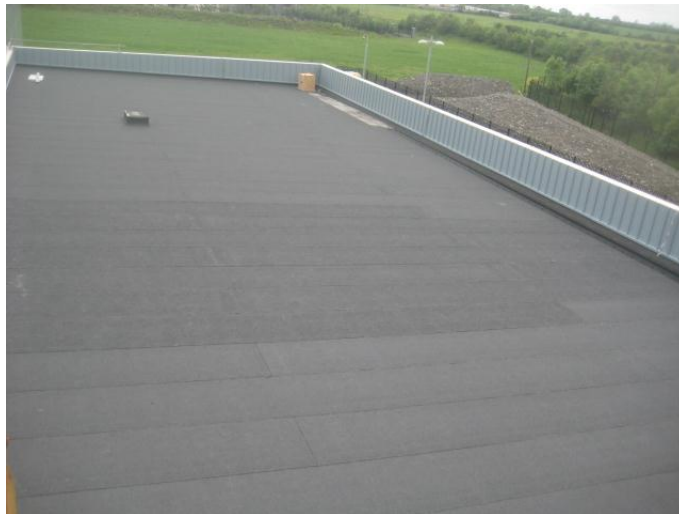
ROOF 7

The Paralon warm roof installation is completed to the main roof field area and upstands.
